# Manhole Inspection Summary

Manhole # S27CC\_026MH

Insp Date: **11/15/07 1:35 PM**

**Location** Address: **611 MOSHER ST**

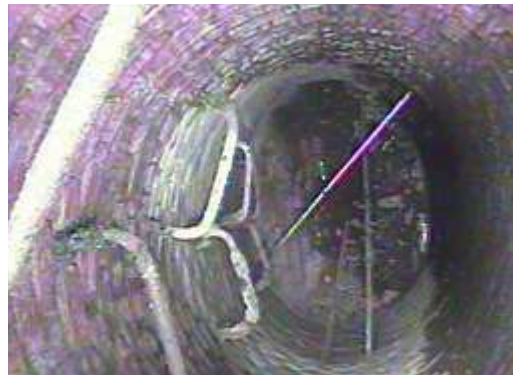
Defect 1

Count: **7** Missing: **0** ☒ **Corroded**

STEPS CORRODED

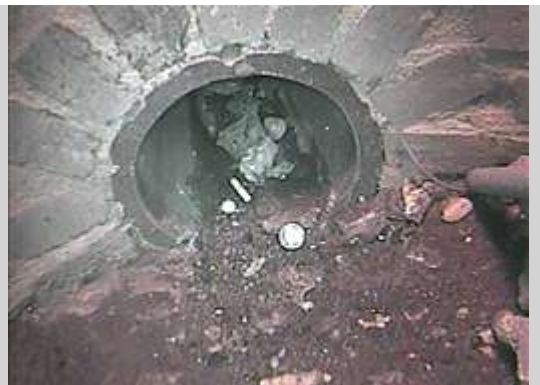
12 O'Clock Outflow

8 in. Circular Gravity Sewer  
Pipe Out @ 12 O'Clock

Deposits: ☐ None ☐ Mud ☐ Sludge ☒ **Debris** ☐ Grease

Silt Depth: **2** (in.) Deposits Extent: **Light**
